# Test Report

## Corrosion Resistance of Oxifree TM198 Coating System

8/19/2013

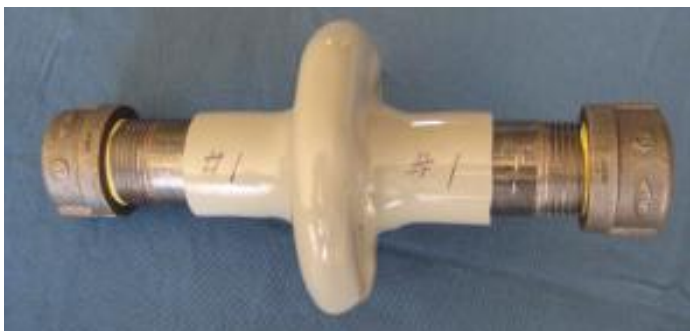
Fig. 2 A New Coated Flanged Sample, steel tube OD= 1.325", both ends capped with some bare metals exposed

Three steel flange samples over-coated with Oxifree TM198 coating system were prepared by Oxifree Co. The test samples are listed in Table 1. A new coated flange sample is shown in Figure 2.

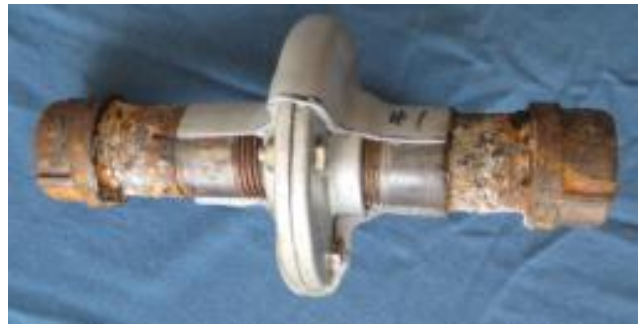
Fig.3B Flange #1-After 3,000 hr Sal Fog with a Cutout

After 3,000 hr ASTM B117 salt fog exposure, the steel flange samples before and after coating cutout are shown in Fig 3. The test results are listed in Table 2.

Sample	Sample ID	DFT, mm	Test Time, Hr	Corrosion Resistance
Coated Steel Flange	121009-1	2.8	3,000	No rusting on flange
	121009-3	3.1	3,000	No rusting on flange
	121009-4	2.4	3,000	No rusting on flange

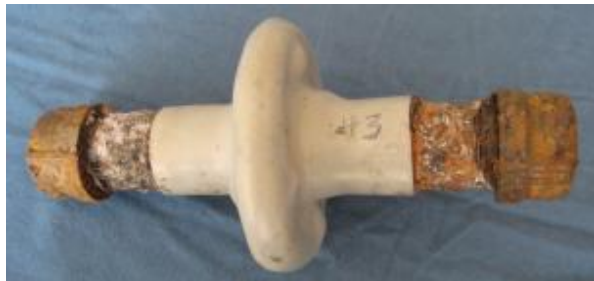
Fig.3C Flange #3 – After 3,000 Hr Salt Fog

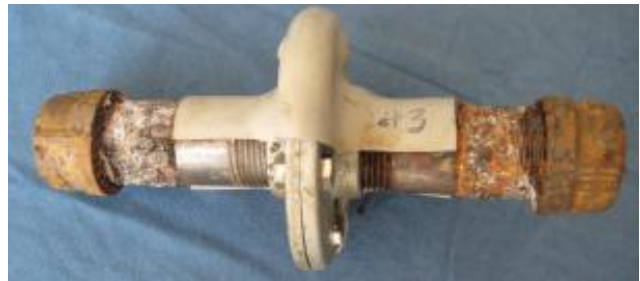
Fig.3D Flange #3-After 3,000 hr Sal Fog with a Cutout

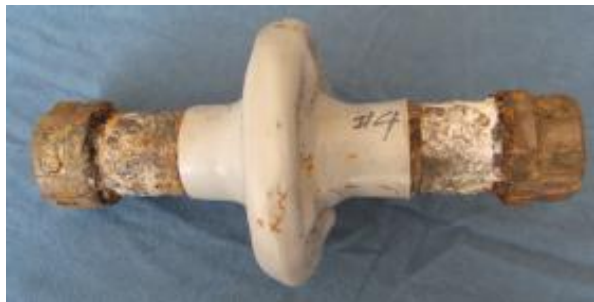
Fig.3E Flange #4 – After 3,000 Hr Salt Fog

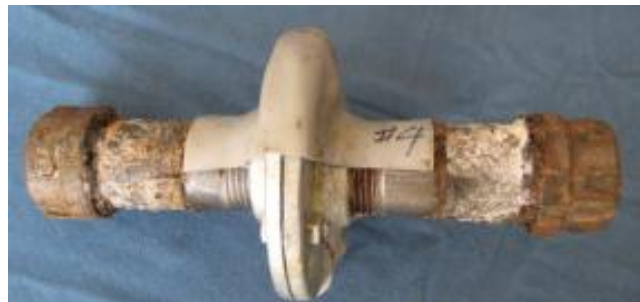
Fig.3F Flange #4-After 3,000 hr Sal Fog with a Cutout
