Oxifree Case Study Food Processing

Location: Vale do Ivaí (Sugar and Alcohol Industry)

Date: 08/24/2009

To prove the efficiency of Oxifree within the Sugar and Alcohol producing industry.

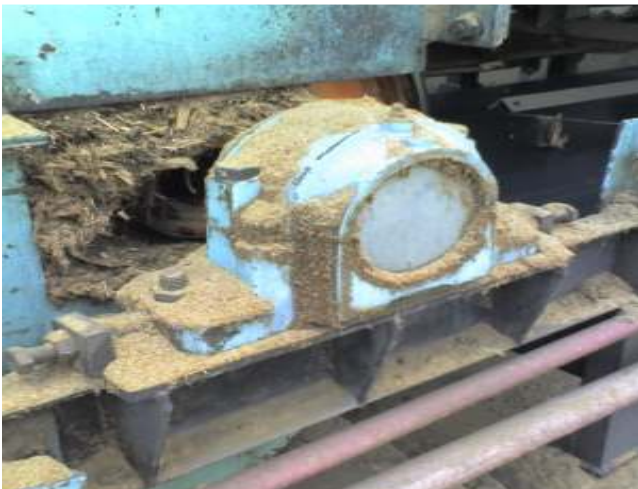
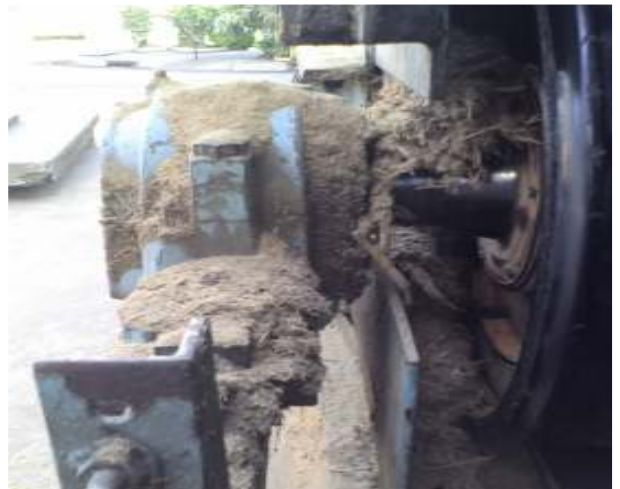
The pictures below show the regular operating conditions of the bearing house without the protection of Oxifree.

Dust particles are able to penetrate the unit damaging it and reducing its useful life.

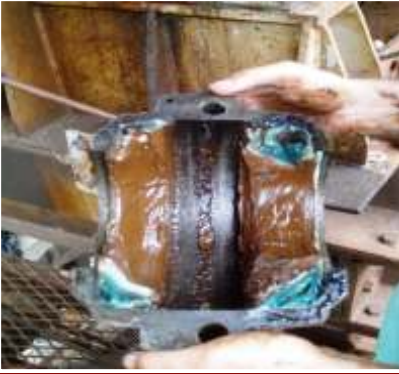
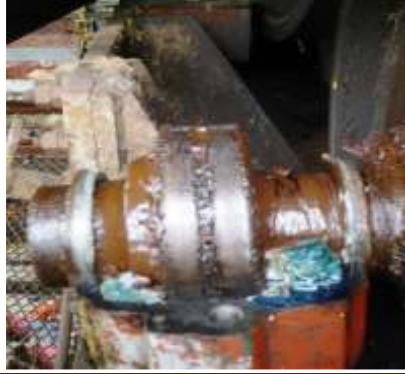
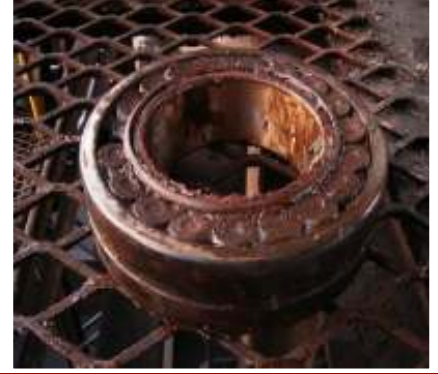
The pictures below show the effects the regular operating conditions (without the protection of Oxifree) have on the bearing house with less than 6 months of use. Note how contaminated the grease becomes.

Due to relentless dust ingress the client suffered, they decided to use Oxifree to avoid any continued contamination. The aim was to reduce bearing replacements resulting in reduced ongoing maintenance expenses.

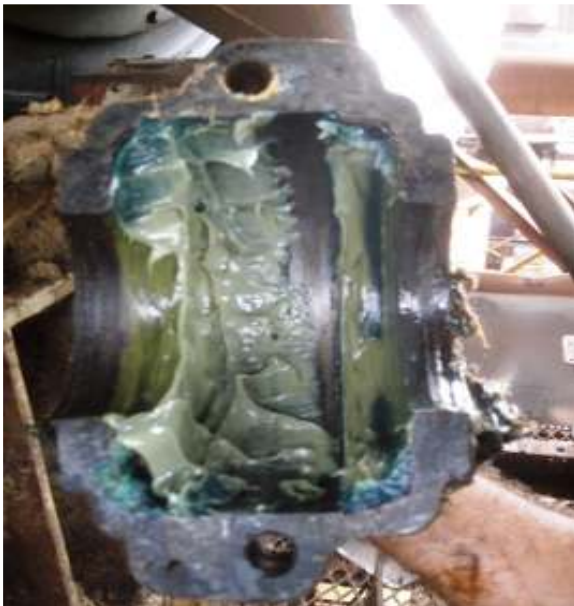
The pictures below show the test bearing protected by Oxifree after one season of use. The bearing was replaced at the same time as the one shown above.

Clean grease (no contamination)

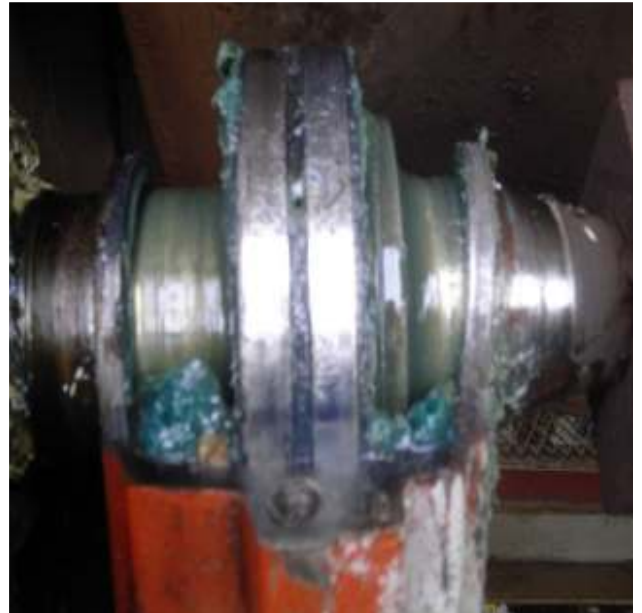
After one season of regular use no particles were found and there was no need for part replacement.

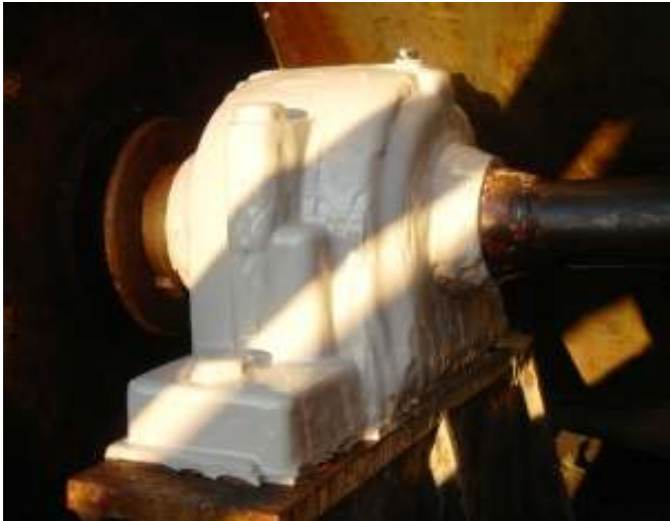
The unit after cleaning, parts replaced and Oxifree applied

Two test units (bearing housings) were opened to be serviced and refurbished. One bearing was reassembled and left as normal, the other was reassembled and applied with Oxifree polymeric resin protective coating. This served as a test study for the efficiency of Oxifree as a shield to the ingress of foreign elements. Both units returned to work.

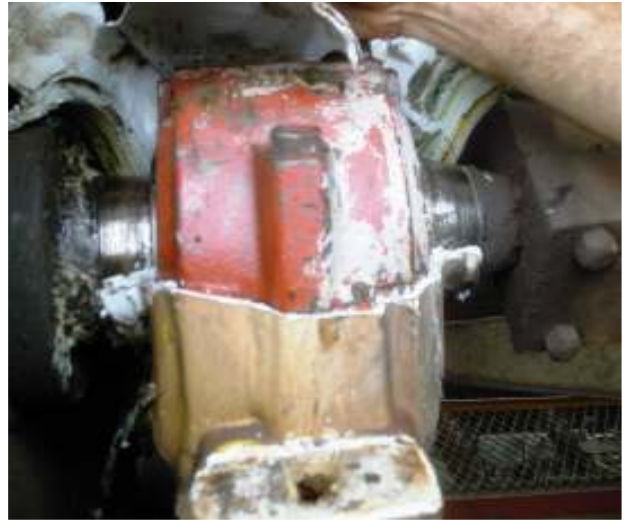
The unit being opened at the end of the season of Oxifree protection

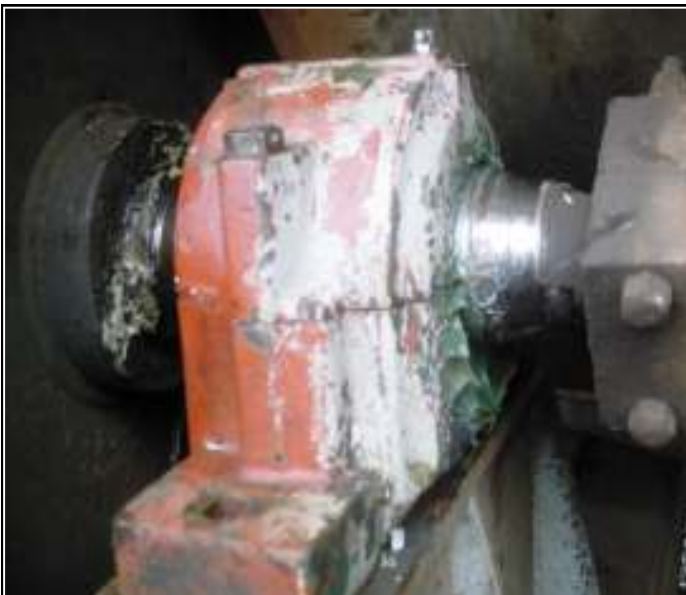
The unit after removing the Oxifree protective coating

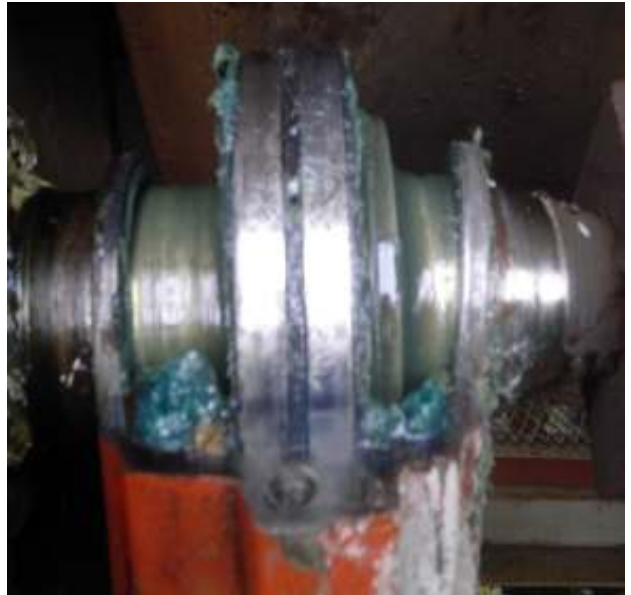
The bearing shows no evidence of contamination

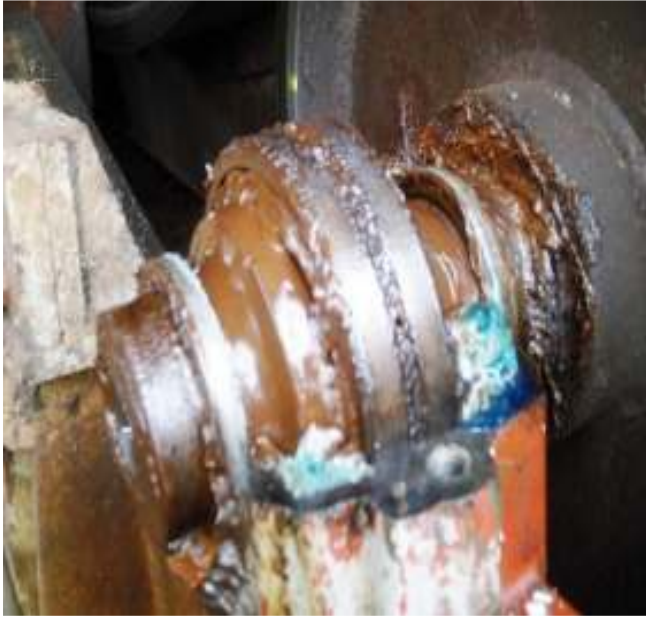
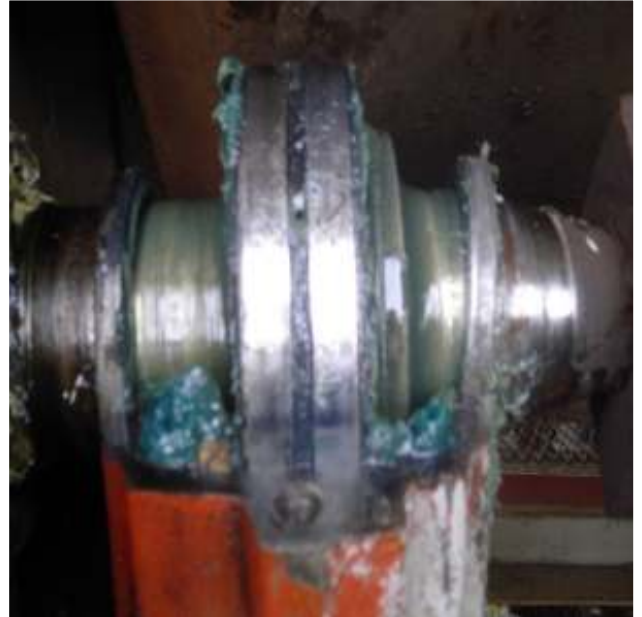
Less than 6 months later the clients' maintenance team opened the test unit without Oxifree and found lots of particles and contaminants in it (see left image).

For the unit protected by Oxifree they waited a whole season (approx. 1 year) and opened the unit to find the internals clean and no dust ingress to be evident (see right image).

The grease inside the unit protected by Oxifree was clean and the bearing was in great operational condition.
