Oxifree Case Study Oil & Gas

Location: Campos Basin (Rio De Janeiro)

Date: August 2008 (project ongoing)

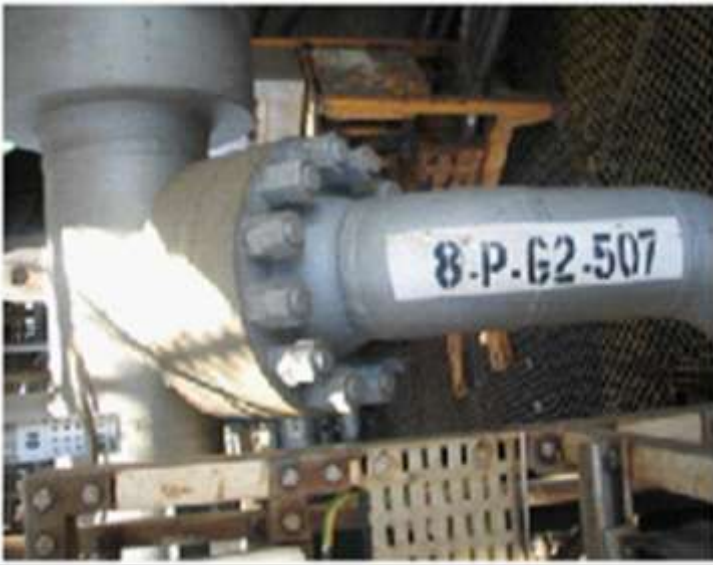
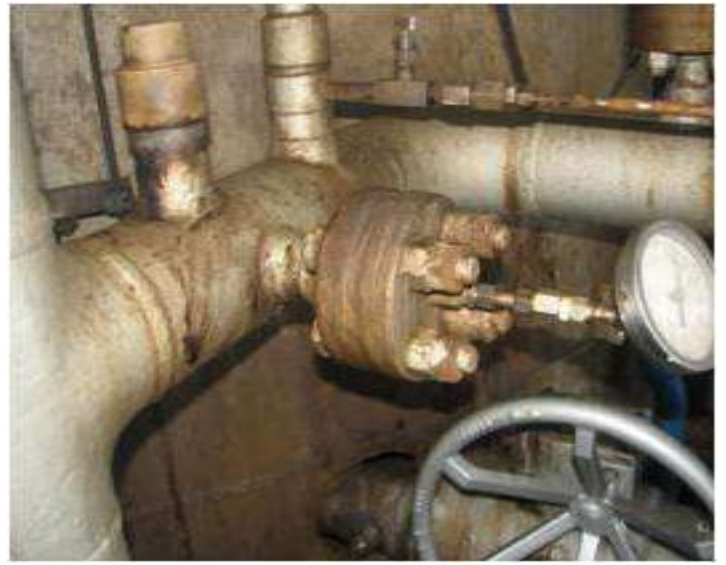
Pictured above are examples of anti corrosive gauze tape containing VCI foam (new and old)

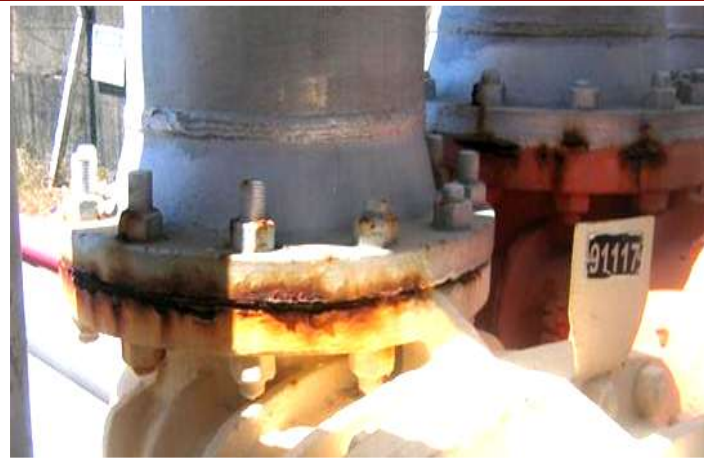
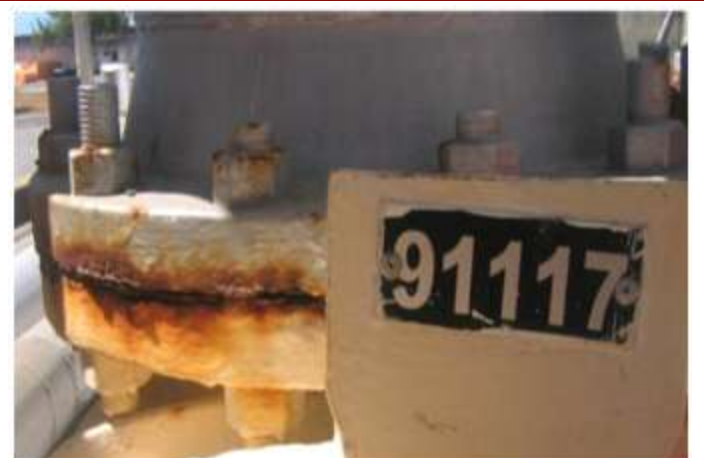
Flanges above are coated with anti-corrosion paint

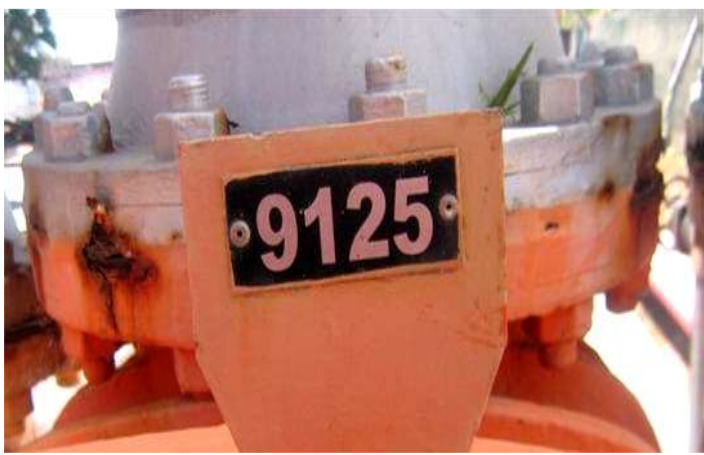
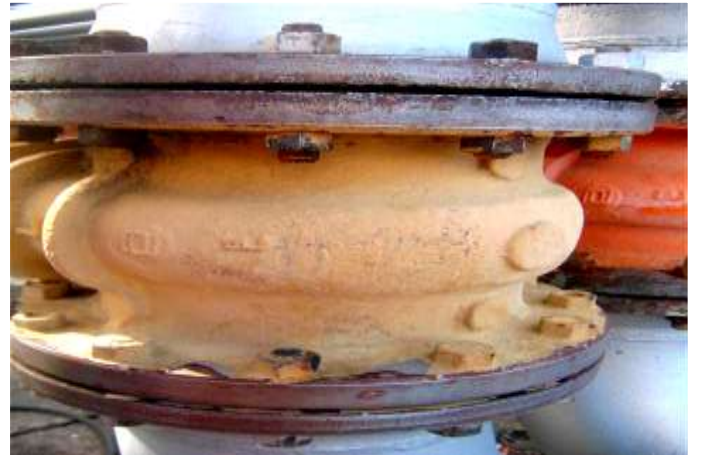
Pictures above show flange prepared for painting -notice the stripped surface

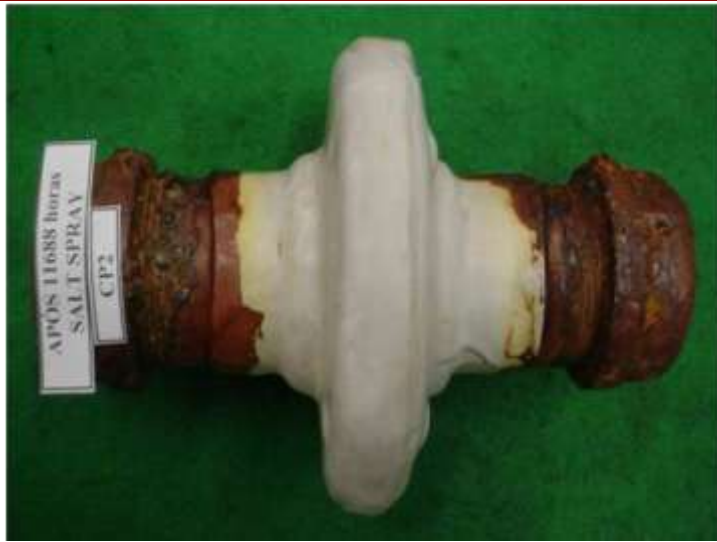
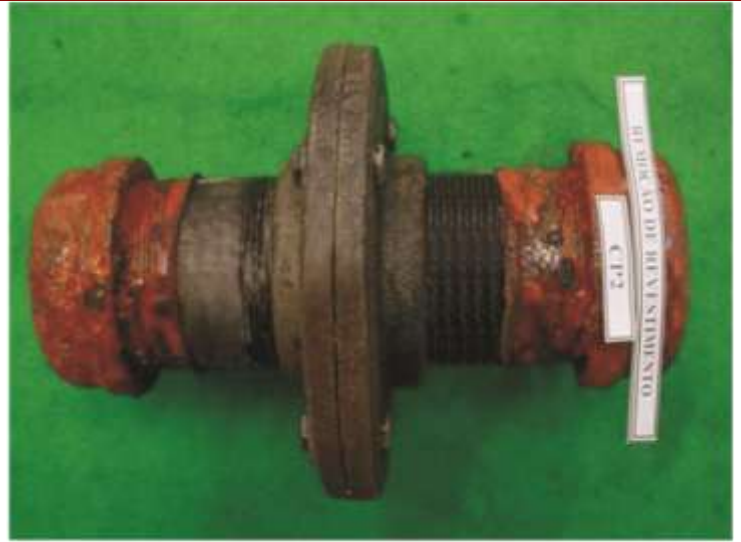
Before Oxifree TM198 material could be used Petrobras insisted on carrying out product approval testing under the industry standard ASTM B117 Salt Spray / Fog Test specification.

The testing was carried out and found Oxifree TM198 material to be effective to up to four times the industry standard of 3,000 hours. The test was halted at 11,688 hours have significantly exceeded the required benchmark.

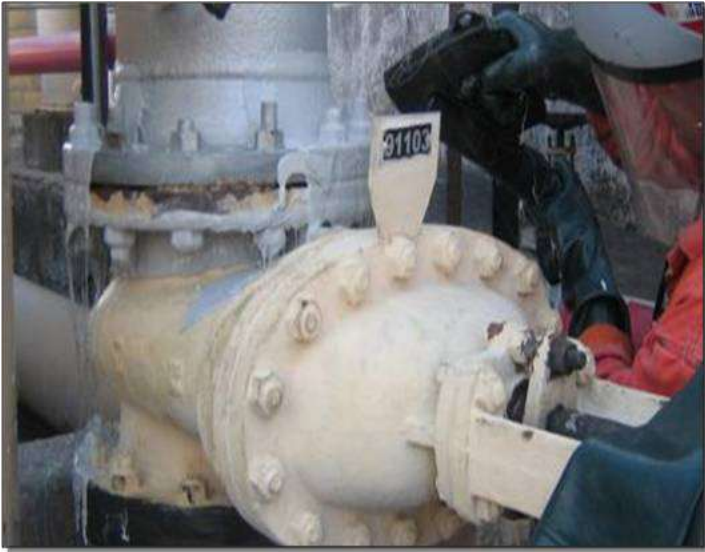
Flange being encapsulated with Oxifree, notice it fills the gap between the flange as well as the bolts / nuts and threads

Oxifree was given full approval for use offshore with work commencing in August 2008 to encapsulate all problem area valves and flanges starting on platforms P1, P19, P32. Oxifree is now considered the de facto anti-corrosion solution for Petrobras on existing structures and has been specified as the coating solution for all critical components on new build platforms.

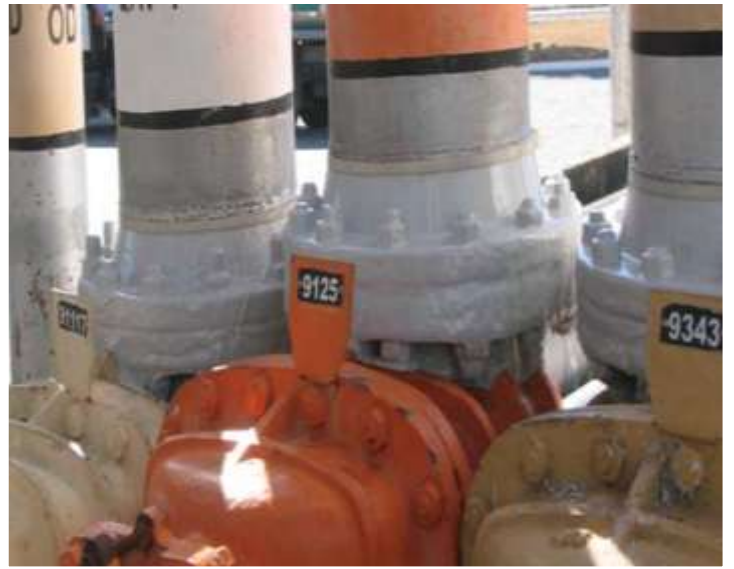
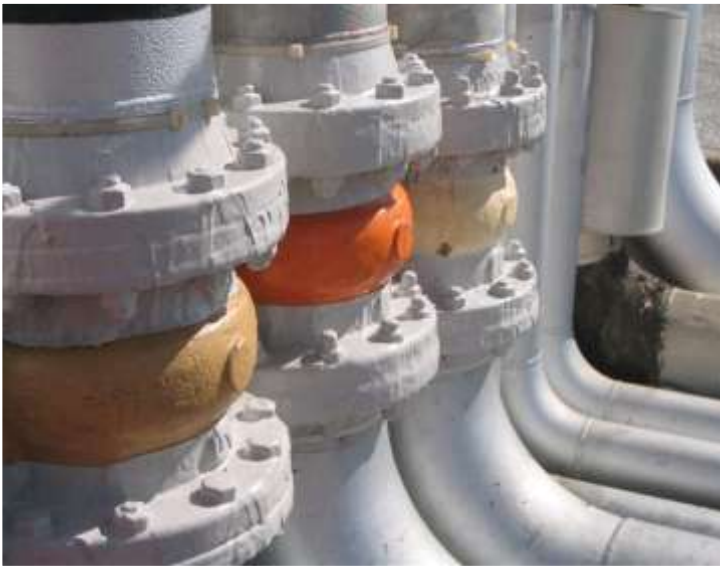
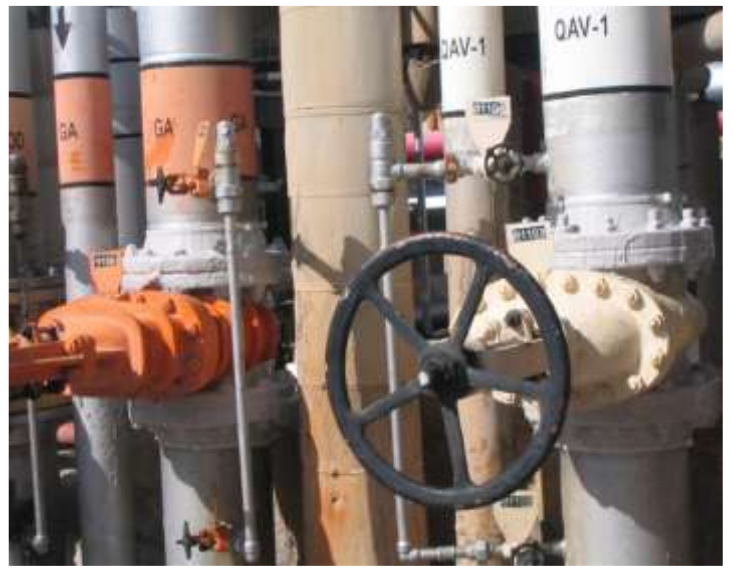
Oxifree TM198 has been applied to a range of flanges
